Aligning Door on 1964 Corvette

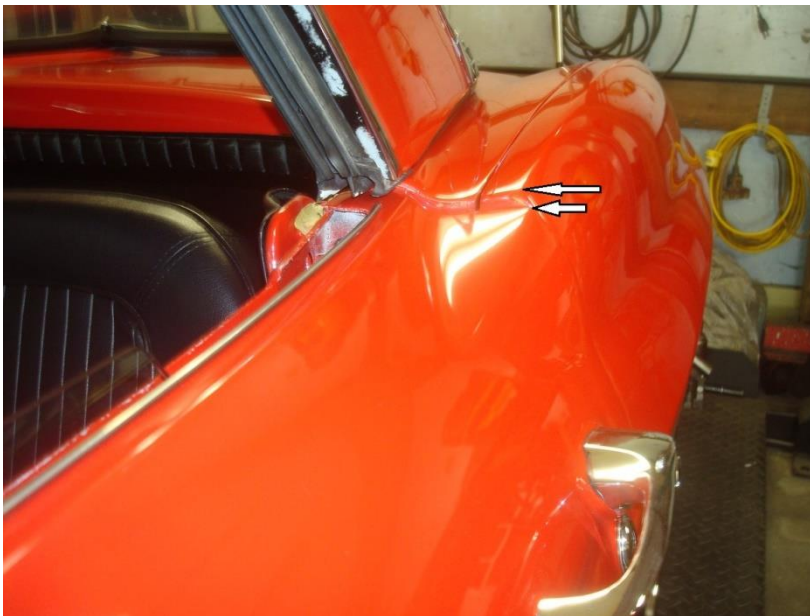
I took the car to Joe Eyl's house to have him guide me on getting the door aligned. See where the rear of the door seems to be lower than the rear quarter panel. It's difficult to see, but the distance between the 2 arrows, shows the improper alignment.

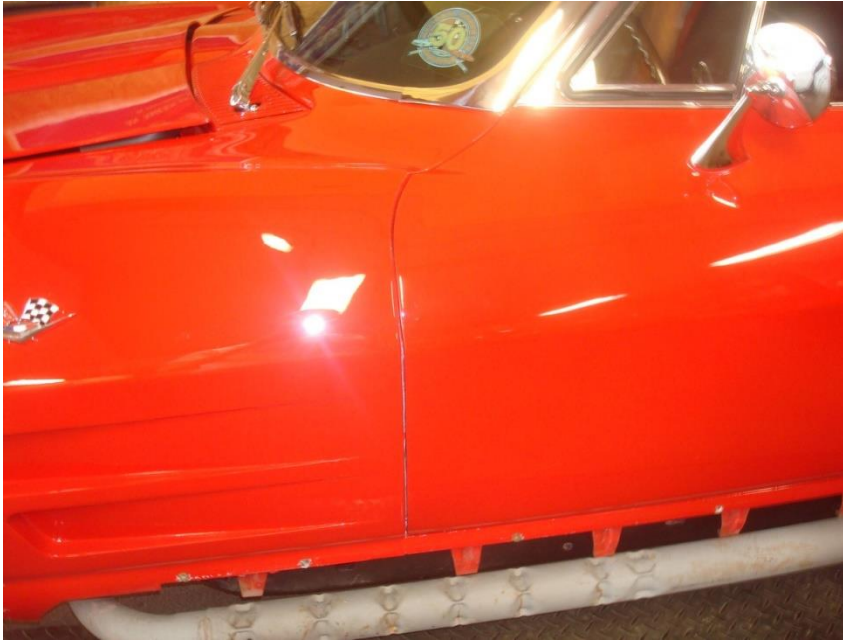
I assume that we would just reposition the hinges that I had previously worked on. Joe looked at the gap at the front edge of the door and determined that approach would not work. Since that gap was pretty well aligned, raising the door on the hinges would make that gap uneven.

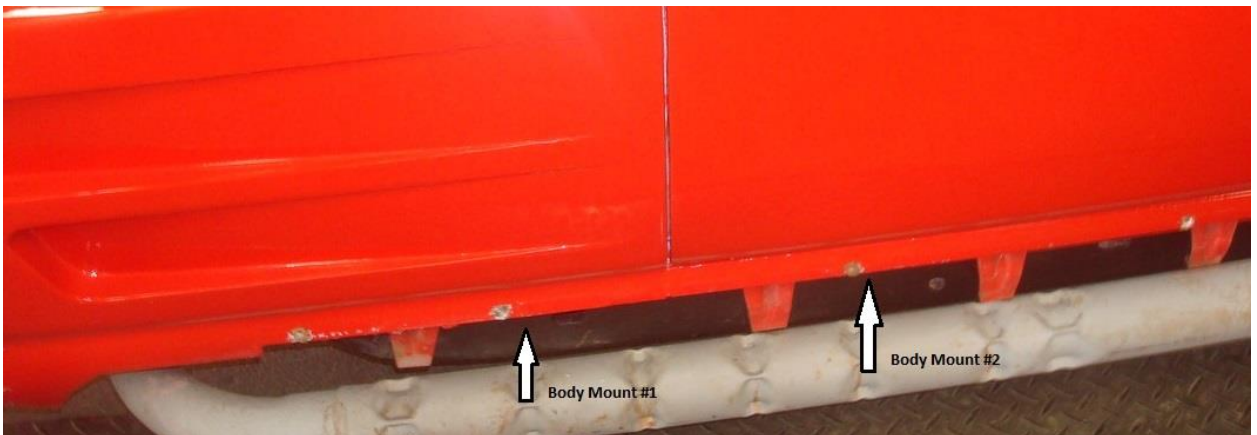
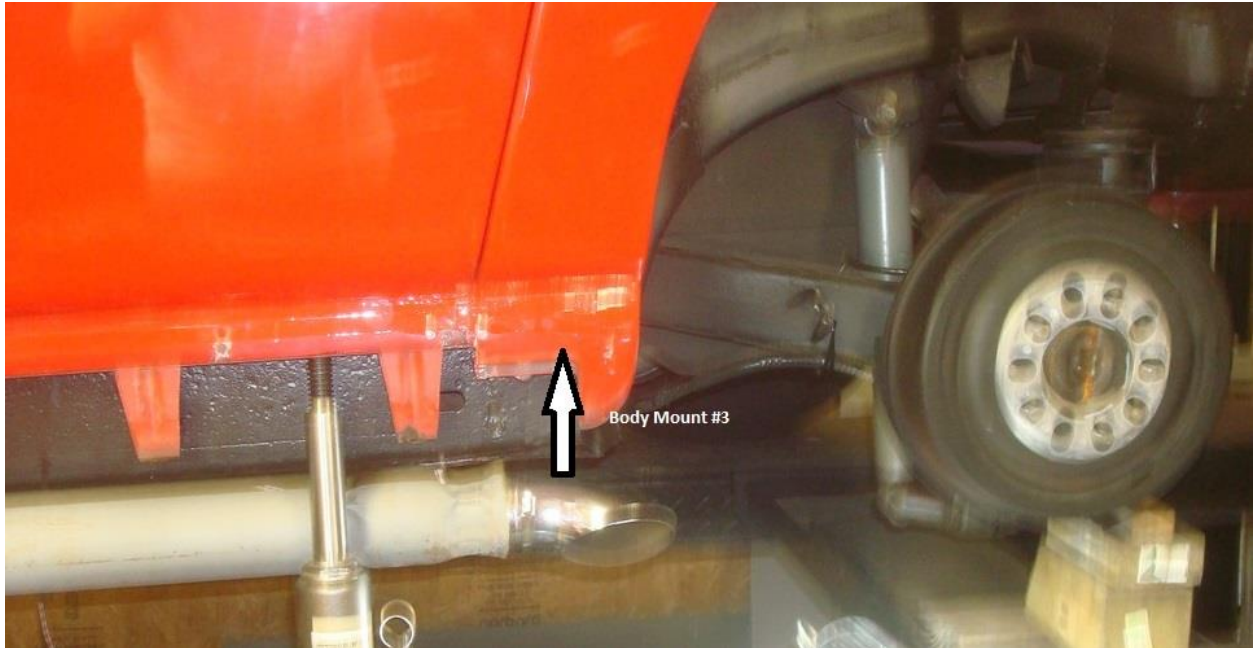
So we were going to re-shim the front half of the car where the body mounts to the frame. Along one side of the car there are 4 body mounts on my car. One just in front of the firewall, second one toward the front of the door, third mount in front of rear wheel opening, and last one behind rear wheel.

In effect we are positioning the front of the car along with the door to point up higher to align with the rear fender. We will use body shims to accomplish this.

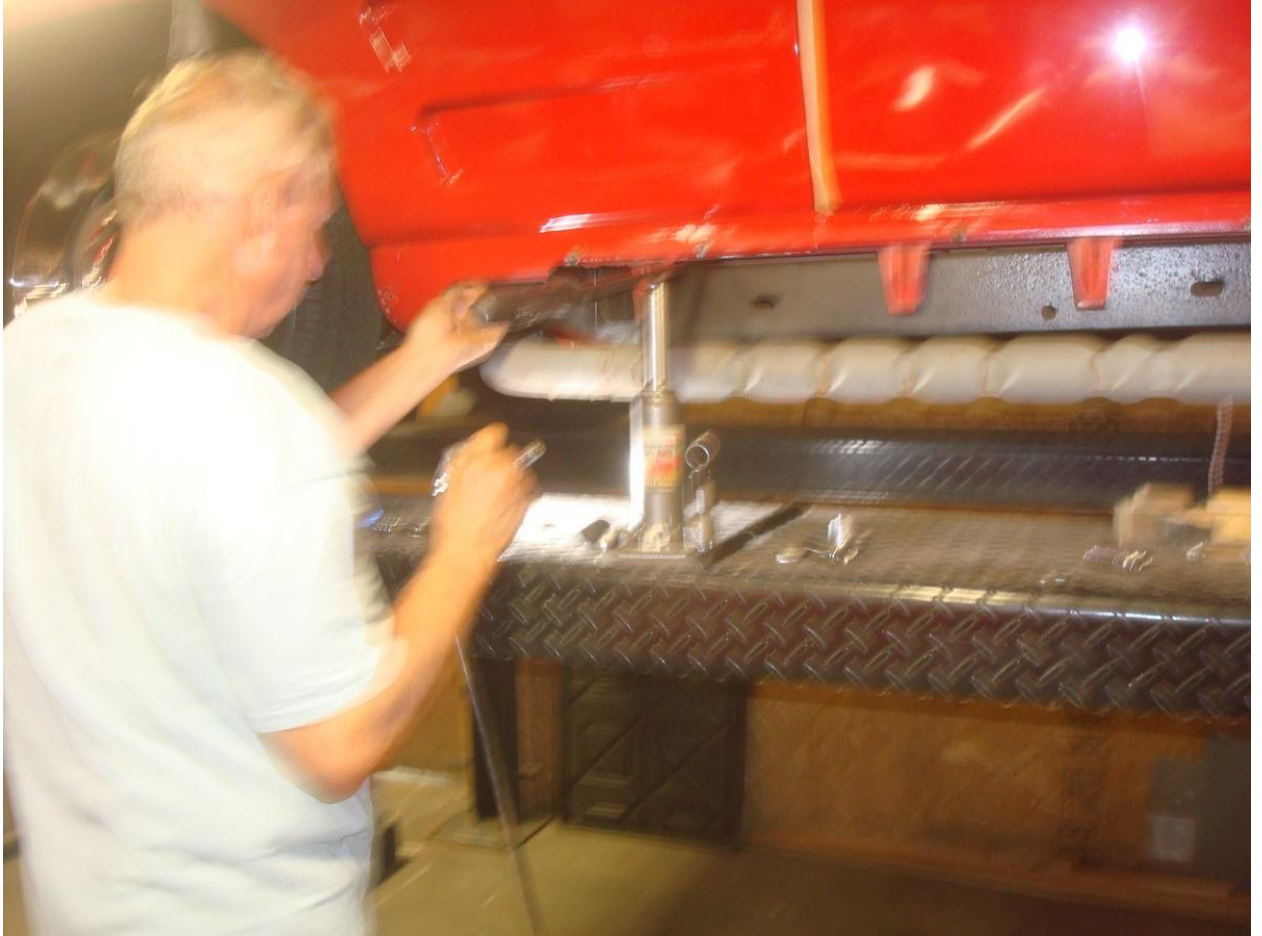
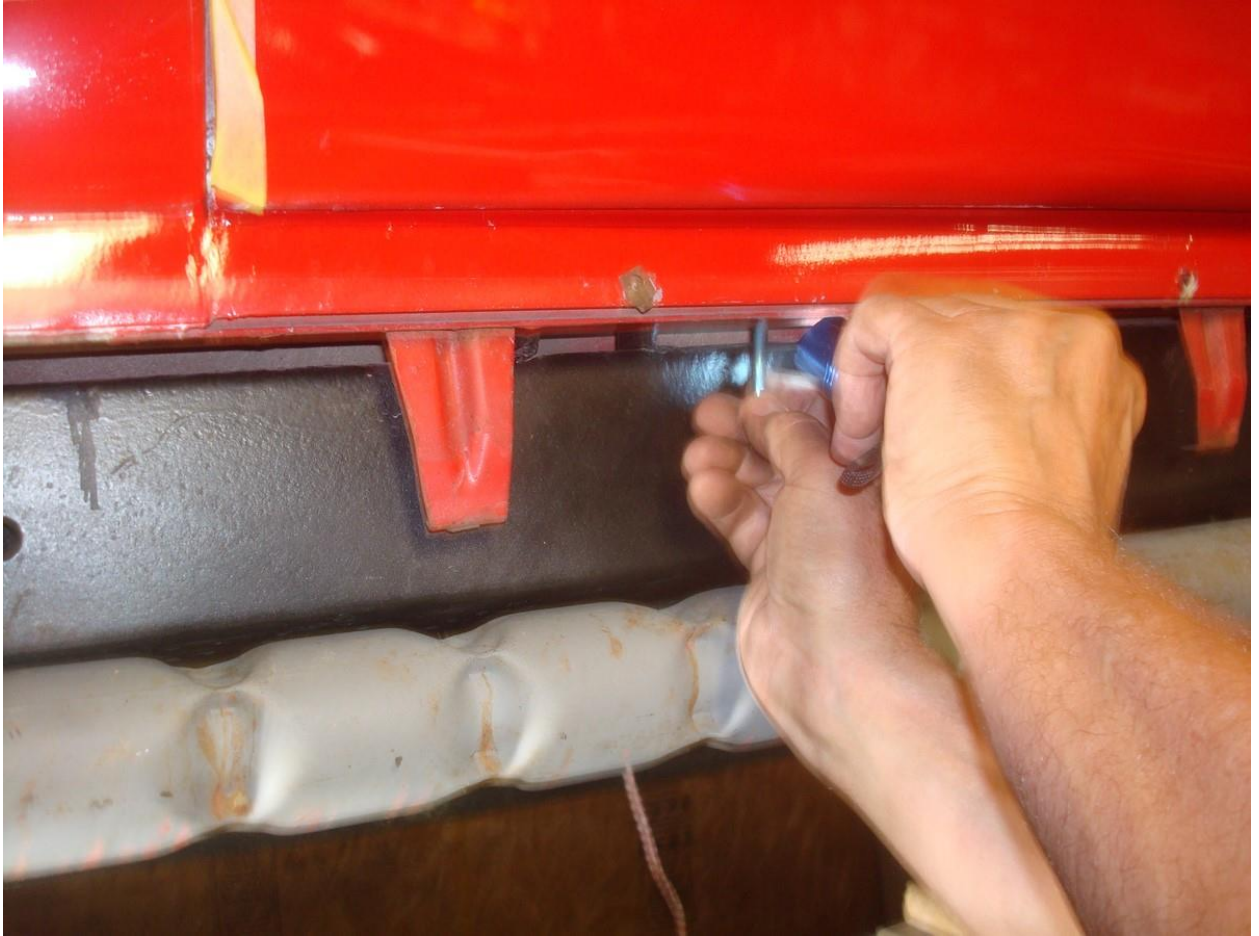
There is very little space between the body mount bracket and the body of the car. We had to remove a splash shield at the front body mount and used a bolt to hold the shims for the second body mount. With a little working, we managed to get the shims in place and slightly tighten them down to see how our alignment was working.

Joe directed me with the number or thickness of shims to raise the car at Body Mount 1 and 2. We raised both of these positions approximately 3/8 of an inch and I removed one thin shim at Body Mount 3.
