The '66 Corvette Challenge

Part 5

Roger to the Rescue...

By Pat Cavanagh NCRS #57907

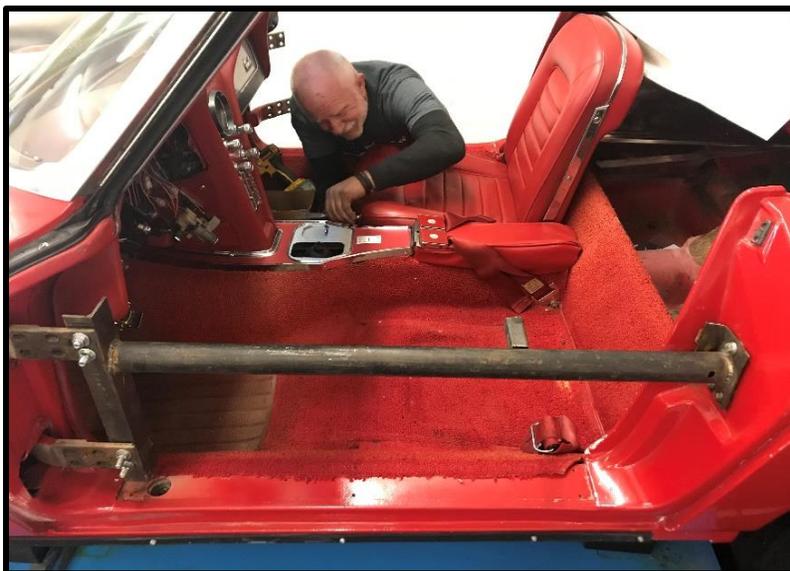
Jon showed us the witness marks on the frame from it being pulled and straightened near the driver's side spring pocket. There was also some minor damage to the number 2 body mount. John said that typically when the corner of the front frame is damaged it also effects the alignment of the engine mounts. It is then very hard to get both the frame and engine mounts to line up again.

Unfortunately, a small amount of misalignment of the engine mounts results in a much larger misalignment of the transmission tail shaft and cross member. My transmission tail shaft mount was several inches out of alignment.

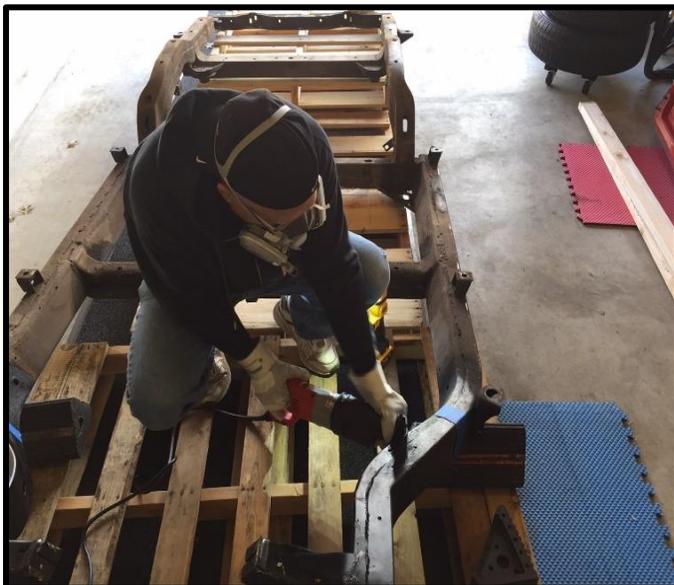
hit on the driver's side front suspension and they tried to pull the front corner of the frame back into alignment, with the body still on the frame. Roger said that with the body on the frame, it is very difficult to get the body, suspension and engine mounts all back into alignment. He thought it was also likely that the driver's side frame rail was low and moved towards the center of the car. Fortunately, the rest of my frame was a rust free and in excellent condition.

We decided the best approach to restore my frame was to splice a undamaged C2 front end on my frame. Roger has proprietary C2 jigs and fixtures to insure the frame is dimensionally correct in three axis's. You will see pictures of the repair process in Part 6.

Fortunately, Roger had a '66 Corvette frame from California that had been in a rear end collision, which would provide the donor front end for my frame. This approach left my VIN numbers on the driver's side intact.
