1965 Corvette Differential Assembly

by Jim Stukenborg

This is the second of the two tech sessions on Jim Stukenborg's 65 Vette coupe.

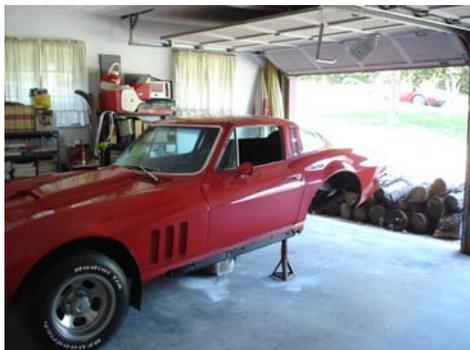
The previous session covered the trailing arms and wheel bearings. This session will cover the re-assembly of the differential. In the previous session write-up it related that the lack of side yolk snap rings as the reason the Vette was taken off the road for the repair that took 16 years. The broken snap rings were found in the bottom of the case. One can only speculate what cause them both to break. Further inspection of the inside of the differential showed very little gear and bearing wear. The side yolks showed only a little radial grooving on the ends. The side bearings were replaced because they were on hand and with the ring gear

removed they are easily driven from the outside in to remove them. Trying to remove them with out taking out the ring and pinion is almost impossible as they are a tight fit to the case and not easily gripped with a bearing puller. The interference fit is the only thing that holds them in place.

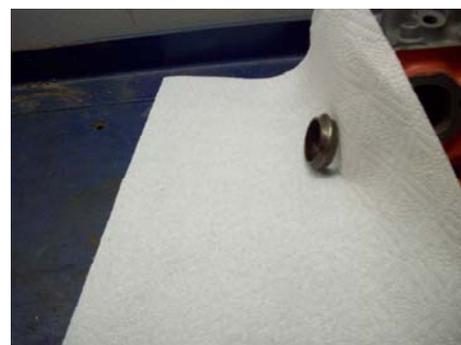
The broken snap rings were found in the bottom of the case. One can only speculate what cause them both to break.

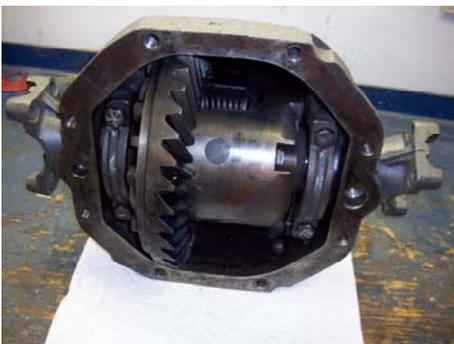
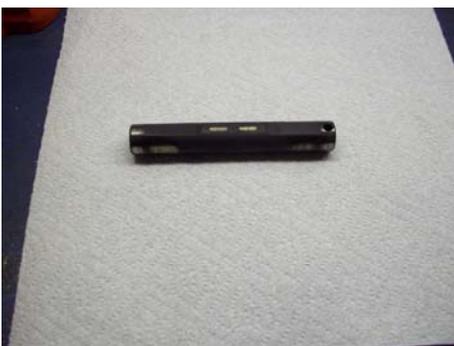
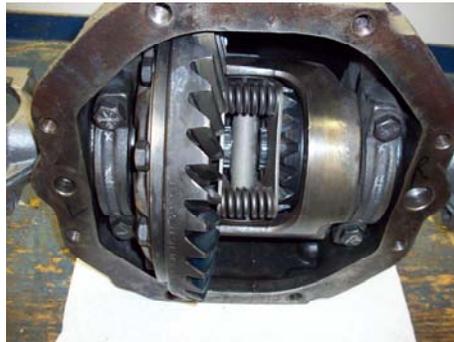
The spider gear shaft was replaced although there was

minimal wear evident. In the design of the C-2 suspension, the half shafts are the upper suspension link and the side yokes rest against

the spider gear shaft and the weight of the car is pushing in against them. In normal

operation the yokes and the differential rotate together. Only if one tire is spinning or a small tire is installed on one side at the rear, or the car is in a turn would the yolk be spinning against the shaft. The slight radial grooving at the ends of the side yokes was removed holding the yokes

upright by hand and carefully sanding the end on a sheet of emery paper mounted on a smooth saw table top using long slow strokes.

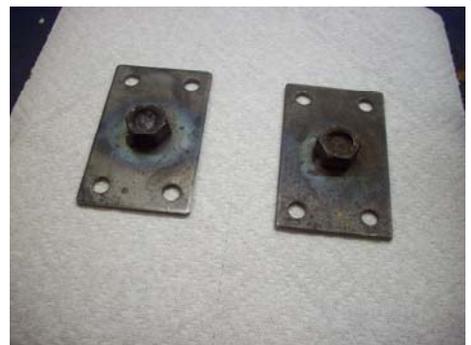
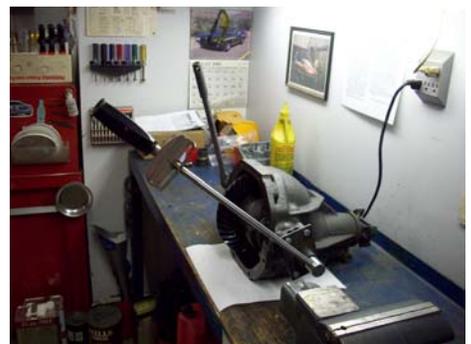
Adapter plates were bolted to the side yokes and a

torque wrench was used to measure the positraction slip force. The torque meas-

ured over 140 ft lbs so the positraction clutches were not replaced. The differential cover was then bolted on the case. A little grease was used to keep the gasket in place while the cover was being installed. It is not

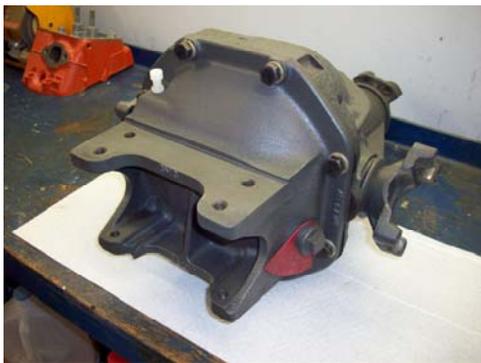
A new breather tube was installed in the small hole at the top rear of the differential

case. The hole had to be deburred to get the tube to go into the hole. Plug the hole first so metal chips do not fall into the differential. The assembly was then degreased and painted with a coating of Dupli-Color gray cast iron and bolted to the differential cross member in preparation for installation back into the Vette. The big rubber cross member cushions were replaced as the metal outer jackets were significantly corroded. The old cushions were removed with a chisel, but a press is needed to reinstall them.
