## 64 to 66 Emergency Brake Pull Handle      Larry Linder

Background:      Emergency brake is hard to operate and ineffective in stopping or holding car on a hill. On most 64 - 66 before 1 April 66 had parking brake lever PN: 3842938 as per assembly manual. This lever did not allow user to apply adequate force to the Emergency operating cable with a reasonable force on the Emergency Brake pull handle. A Technical Service Bulletin TSB #66-59, HIGH PARKING BRAKE APPLICATION - was issued on May 4, 1966 to instruct dealers to modify the emergency brake bracket and install a new lever.

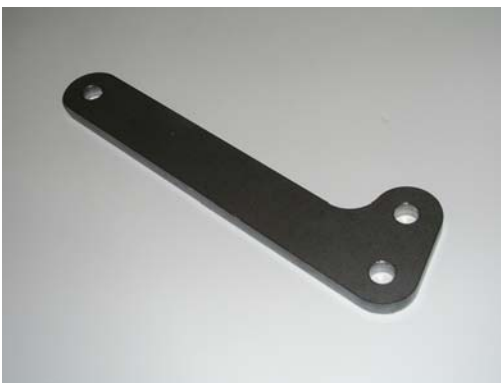
Fig 1: 64 to E66 Lever PN:3842938

PN 3842938. (1st Design)

The first design is from a 65. Correct finish is bare steel and not painted.

After 01 April 66 the lever used in production was changed and was assigned PN:3899399. This new design changed the linkage ratio from 4.800 to 5.714, increasing the force applied to the rear emergency brake cable. Assuming a 30 lb pull on the brake handle the brake application force increased to 173 lb from 144lb. The levers are very similar, the long dimension is the same, the short dimension was reduced, the overall shape is the same, no PN was stamped on them, and they can be identified only by the dimensions. The major hole to hole dimension is 6.00 " in all cases. The 1st design had a secondary hole center to center of 1.250". The second design had a secondary hole center to center of 1.020"

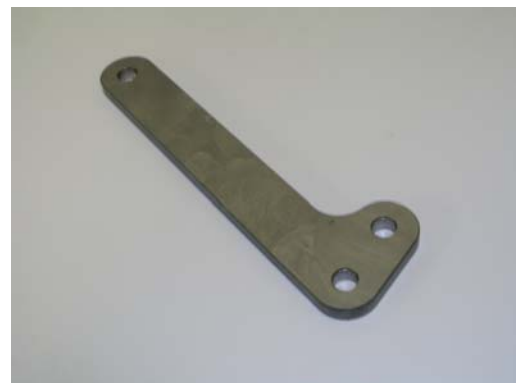
Fig 2: L66 Lever

PN 3899399. (2nd Design)

The second design is a new part. The new lever is phosphated to

reduce corrosion. It was checked using a lever from a known original 66. SN 24,xxx  
22 June 66

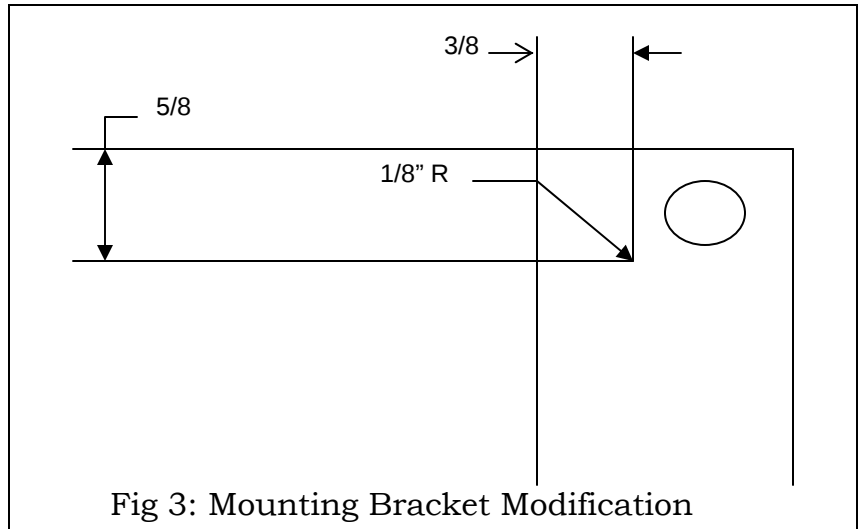
Factory frame mounting bracket modification occurred before the new lever arm was available for production. Several earlier 66 cars with lower SN (16,nnn) numbers were checked and they had the notch in the emergency brake bracket but had the 1st design lever.

The bracket notch is  $3/8 \times 5/8$  with a  $1/8$  in radius. See Fig 3:

Replacing the 1st design lever with the 2nd design requires that a clearance notch be cut into the frame mounting bracket. The service bulletin describes this modification. You can use a small hack saw, or die grinder with a burr to make the notch in the bracket. After you are satisfied that adequate clearance for the pull rod end is available mount the lever to the frame bracket. It is time to clean and paint the modified frame bracket. Assemble as in the service manual, and make final adjustments.
