Winter Time Fantasies by Terry Brim

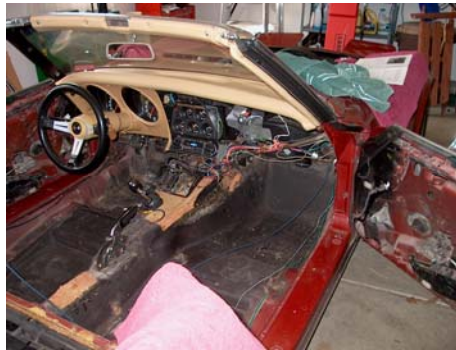
I thought I would start by removing the complete interior since I was going to either replace or restore everything except for the seat covers. (I had redone the leather seats about 12 years ago,

Replacing the carpeting went fairly smoothly. Since I had done this about 12 years ago, I sort of knew what to expect. The one thing I did learn from my previous experience was remounting the seats. This time around, I re-

moved the runners from the seats and fastened them to the floor first to get the correct holes cut in the carpet for the mounting bolts and front flaps. Once this was done, I remounted the seats back on the runners and then bolted the seats to the floor.

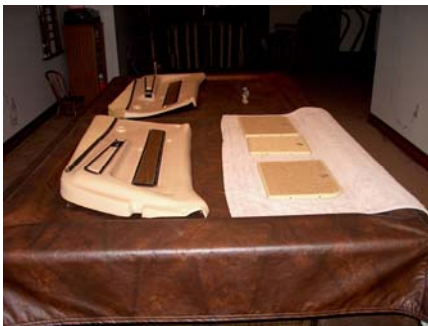
After that came the job of sprucing up the door panels. The carpet strips needed to be replaced along with the faded wood grain trim panel. With the aid of a staple gun, replacing these items went well, or so I thought at the time. What I didn't realize was that I would have to redo the door panels! Lesson here is if you plan on re-dying any part of your interior (especially if it is a light color like saddle) you had better plan on doing ALL the interior parts as the after market dye colors vary from the original which is usually faded after a number of years. Since I had only ordered 2 cans of spray dye that took 3 weeks to arrive, I knew I would have to move on to other things while I waited for the additional

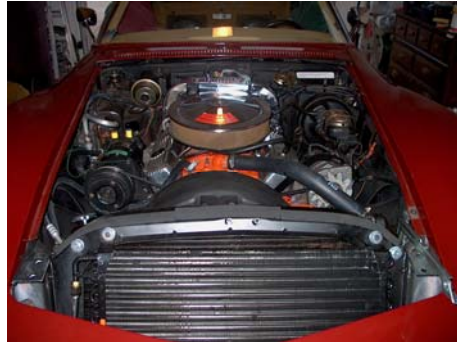
While I awaited the arrival of more dye, I began to attack the engine compartment. I had plenty of things to do here starting with the radiator seals. After much deliberation, I decided I would have to pull the radiator in order to replace both radiator to fan shroud and radiator to support seals. Since the car had

A/C and the condenser was in front of the radiator, I opted not to pull the condenser, but rather to remove the fan shroud and pull the radiator out leaving the condenser in place and the A/C system untouched. I

In retrospect, I'm not sure this was a wise choice! Had I to do it over again, I probably would have opted to pull the condenser and take the radiator out the front. In order to get the fan shroud out, I had to remove the fan blade and harmonic balancer along with the alternator and all the belts. Even then, getting the fan shroud out with the radiator still in place was a very difficult task.....Little did I know the half of it! On the plus side, once I finally managed to get the fan shroud out, the radiator came out fairly easily. I encountered no problems in putting the radiator back with the seals firmly in place between the radiator and the radiator support. The nightmare started when I tried to put the fan shroud back in the car.

To make a long story short, it took me the better part of a day to finally get the shroud back in the car. The GM engineers must have stayed awake at night figuring out how to design every nook and cranny so that there was only one way to get the shroud back in the car with the radiator and engine still intact. I found the key is to start with the lower left hand corner of the shroud first and then push, tuck, bend, cuss and swear until finally it went back in place....All during this time, making sure the self adhesive seals remain on the shroud. If they are not in place when the radiator and fan shroud finally mate, it is all but impossible to get the seals in place once both are back in the car.

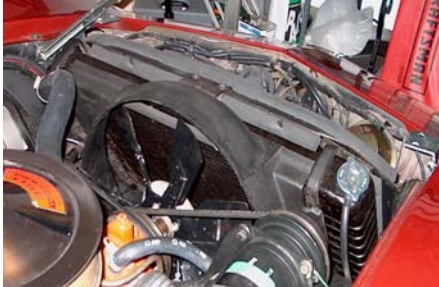
shutoff valve was another story in and of itself. Someone in an earlier life had replaced the shutoff valve, but had done so with an after market valve that did not have a mounting bracket. As a result, for years, I had seen the shutoff valve in line with the heater hose visible along the left firewall. When I ordered a new shutoff valve that was correct for a 70 350/350 with AC, it came with a mounting bracket attached to the valve. Now the question became where was the original mounting place for the valve.

After much research and lots of calls trying to find an original 1970 350/350 AC car with the original hot water shutoff valve still in it's original mounting place, I discovered the secret mounting place for the valve. It was hidden behind the egg crate side louver on the passenger side of the car mounted to the inner fender skirt. After removing the side louver and looking at where it should have been, to my amazement, there were the

mounting holes with the right spacing that matched the holes in the bracket perfectly.

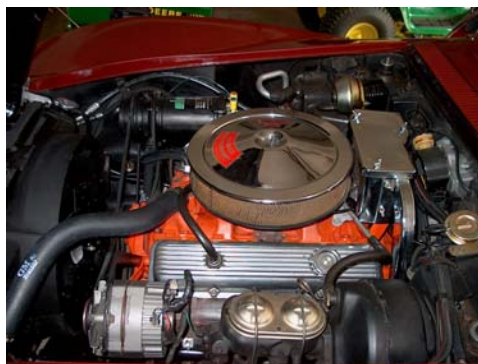
Next came removal and re-polishing of all the chrome distributor cover and spark plug wire covers. While the distributor cover was off, I checked the distributor tags for the correct numbers and replaced the cap with an original GM cap. The numbers indicated that the distributor and coil were original!

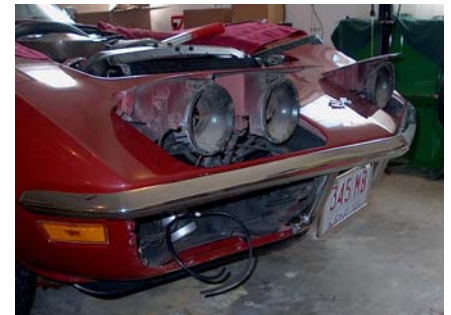
Upon inspecting the washer system further, I noticed that the washer hose going to the headlights was gone as was the left metal tube running along the left wiper arm. A complete washer

hose kit was available aftermarket, so out with the old washer hose and in with the new. Replacing the metal tube along the left hand wiper arm along with the new hose and clamps was yet another story. In order to get at it, I had to remove not only the wiper grill, but the entire wiper door.....believe me having fat fingers is not an advantage here!

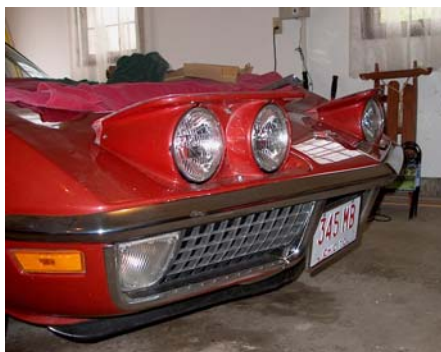
wire which allowed me to splice in the old harness wire where it had broken off from the plugs. Word of caution here when replacing the headlight bezel, be very careful not to over tighten the screws that attach the top of the bezel to the headlight door.

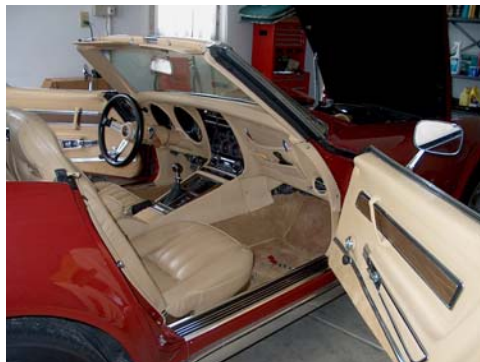
the interior dash, center console, door panels, rear quarter panels, and rear storage compartment back in the car took about a day. The finished product looked pretty much original except for the aftermarket radio which I have had in the car for about 8 years and opted to just
