The '66 Corvette Challenge

Part 6

“Like it Never Happened...”

By Pat Cavanagh NCRS #57907

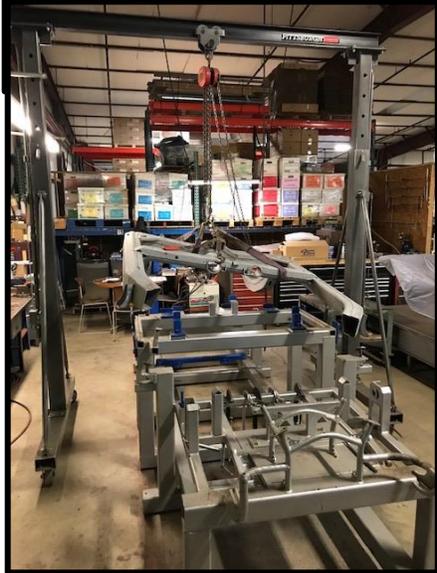
Shortly after Roger received my shortened frame, he cut the front section off his donor frame. He then sent my shortened main frame and the donor front section out to be sand blasted. Sand blasting confirmed that my main frame and the donor front section were solid and rust free.

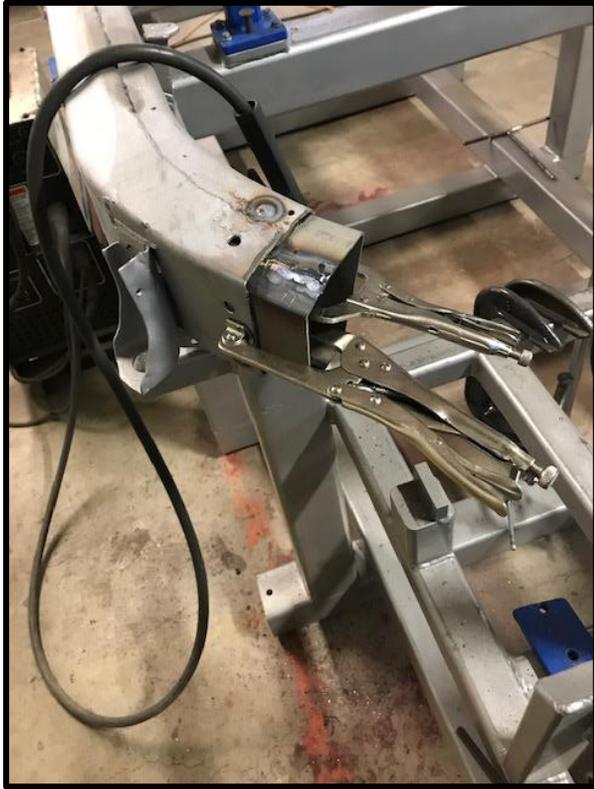
When they came back from sand blasting Roger mounted my frame in his C2 jig and did a thorough inspection. As he had suspected earlier the driver's side frame rail between the transmission cross member and the firewall body mount was $\frac{1}{2}$ inch low and $\frac{1}{2}$ inch too far inward as a result of the accident and the poorly done repair job. Roger used his frame table and fixtures to bring the driver's side rail

back into position and then he waited 24 hours to insure it did not

return to its previous distorted position. It seems these old frames sometimes have a memory!

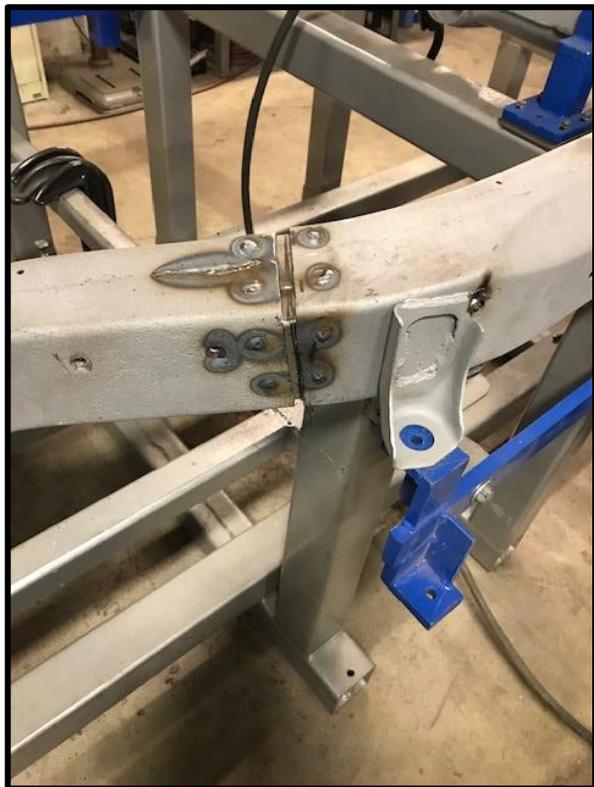
Once Roger was sure that the frame section was perfect, he confirmed it in the jig. Next, he measured to make sure the donor front end would splice together at precisely the right point with the main frame section. Then Roger inserts specially made 1/8 inch thick steel sleeve into both frame horns that have the same geometry as the inside of the frame rail.

Once both frame sections were mounted in the jig, and the gaps were correct, multiple 3/8 inch holes are drilled in the frame rails and the sleeves are spot welded to the frame rails. As you can imagine there is a sequence to this procedure to insure the front frame section is correctly attached and aligned to the main frame section. Finally, the frame is welded together at the junction of the two frame sections.

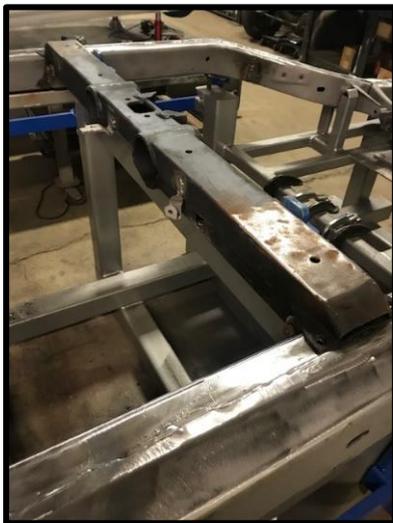
Roger prefers to completely replace the fixed cross member with a C3 Corvette removable cross member when he adds this feature to a C2 frame. He feels it is stronger, lighter and less expensive than many of the aftermarket kits.

Chevrolet started using a removable cross members with Turbo 400 automatic transmissions in C3 Corvettes in 1968. In 1981 Chevrolet began using the removable cross member in manual transmission C3 Corvettes also.

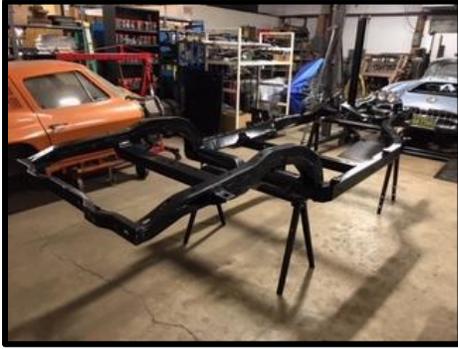
Roger removed the fixed cross member from my frame and welded in the brackets and tabs to make the C3 removable cross member work correctly in my C2 frame. This includes the emergency brake bracket that is specific to the '66 Corvettes. Roger also included the C3 transmission tail shaft bracket for my Muncie 4-speed transmission that works with the new cross member.

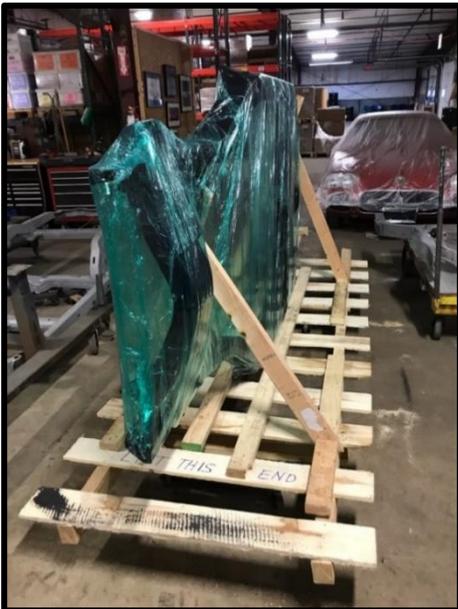
When the frame was finished and all the dimensions were confirmed on the frame jig, the frame was sent out for a second sand blasting and powder coating. It was then bubble wrapped and shipped.

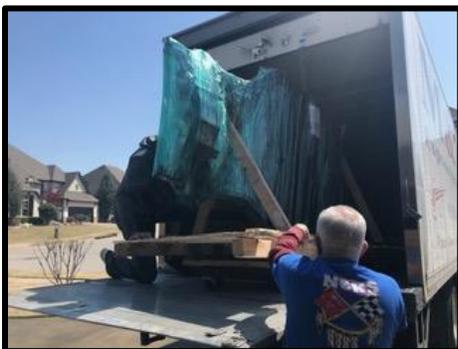
With the long pallet required for the finished frame, the lift gate was not wide enough to drop the pallet in my driveway. I had to use my engine hoist to support one end of the pallet and coordinate lowering it to the driveway with the liftgate.
