Aligning Door on 1964 Corvette

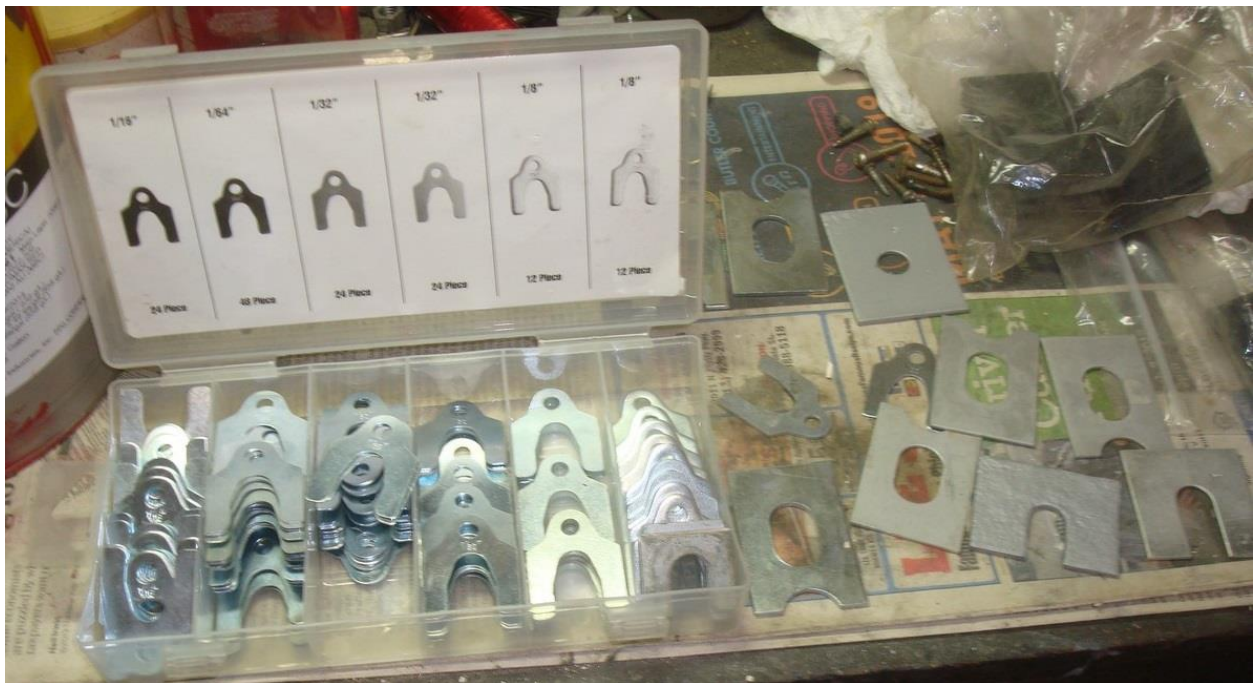
In effect we are positioning the front of the car along with the door to point up higher to align with the rear fender. We will use body shims to accomplish this.

Joe directed me with the number or thickness of shims to raise the car at Body Mount 1 and 2. We raised both of these positions approximately 3/8 of an inch and I removed one thin shim at Body Mount 3.
