The '66 Corvette Challenge

Part 5

Roger to the Rescue...

By Pat Cavanagh NCRS #57907

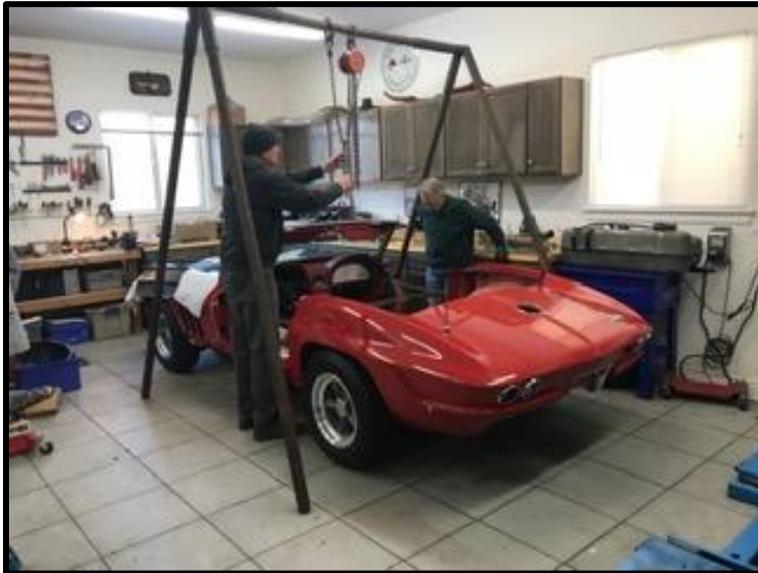
I preferred to fix the existing frame but it was not going to be an easy fix. If I was going to autocross or race this car, it had to be safe, correct and strong.

Regardless of which approach I took, the frame had to be removed from the body. With the help of Scott, Kelly and Charles Buxton we set up Scott's A-frame gantry in my workshop and pulled the body off the frame.

With the engine, transmission, gas tank, steering column and body mounts removed, the body came off in an afternoon.

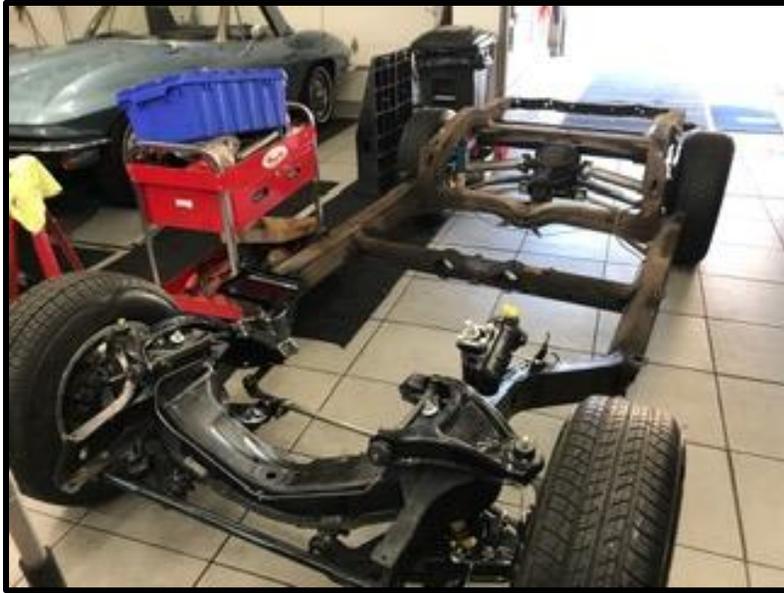
After we stripped the frame, I made calls to several frame shops in Tulsa, they all confirmed that they did not have laser alignment data for C2 Corvettes and it was a trial and error process

(my words) to bring the frame data points back to the original dimensions. That made me uncomfortable.

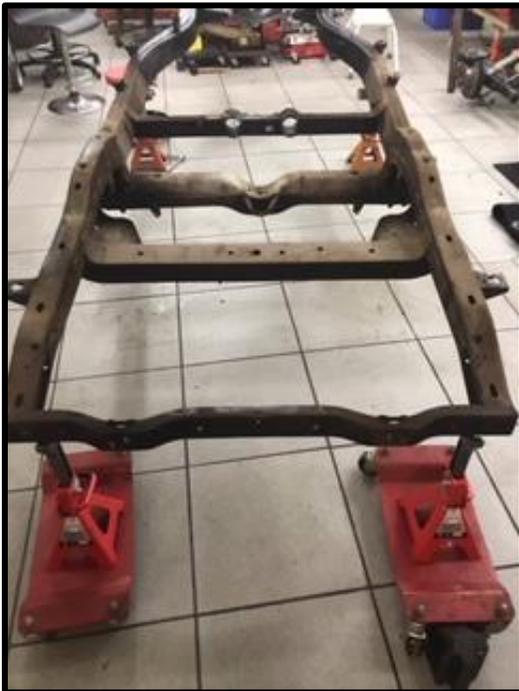
While Roger had several beautifully restored C2 frames available for sale, I decided to have mine restored, preserving my VIN numbers and saving me future title and ownership headaches. I was particularly impressed with the C2 frame jig in his shop that insured a straight and true frame.

Roger and I had several conversations. I emailed him multiple pictures of my frame from different angles. His analysis after studying the pictures was very similar to Jon's. The car was

hit on the driver's side front suspension and they tried to pull the front corner of the frame back into alignment, with the body still on the frame. Roger said that with the body on the frame, it is very difficult to get the body, suspension and engine mounts all back into alignment. He thought it was also likely that the driver's side frame rail was low and moved towards the center of the car. Fortunately, the rest of my frame was a rust free and in excellent condition.

We decided the best approach to restore my frame was to splice a undamaged C2 front end on my frame. Roger has proprietary C2 jigs and fixtures to insure the frame is dimensionally correct in three axis's. You will see pictures of the repair process in Part 6.
